DAN HOLE POND DAM

NH 00376

PHASE I INSPECTION REPORT
NATIONAL DAM INSPECTION PROGRAM

NOVEMBER 1978

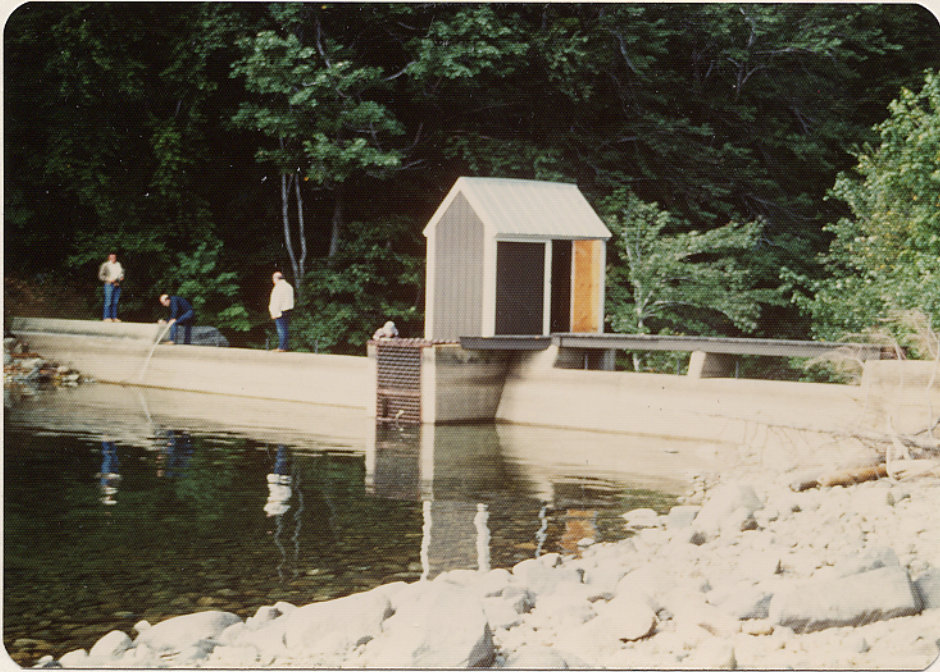
Overview from right side upstream

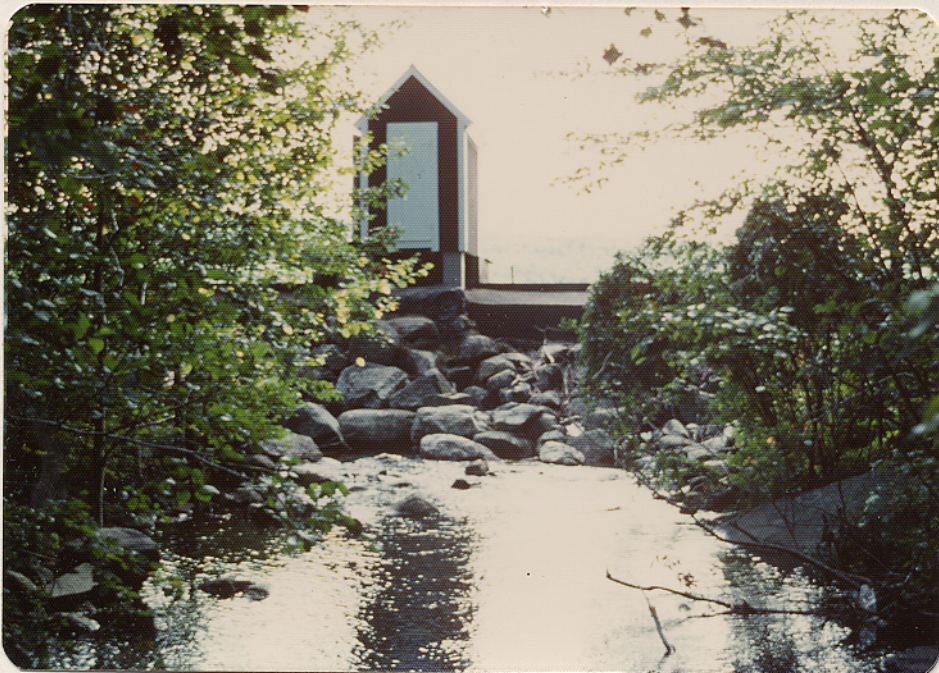
Overview from left side downstream

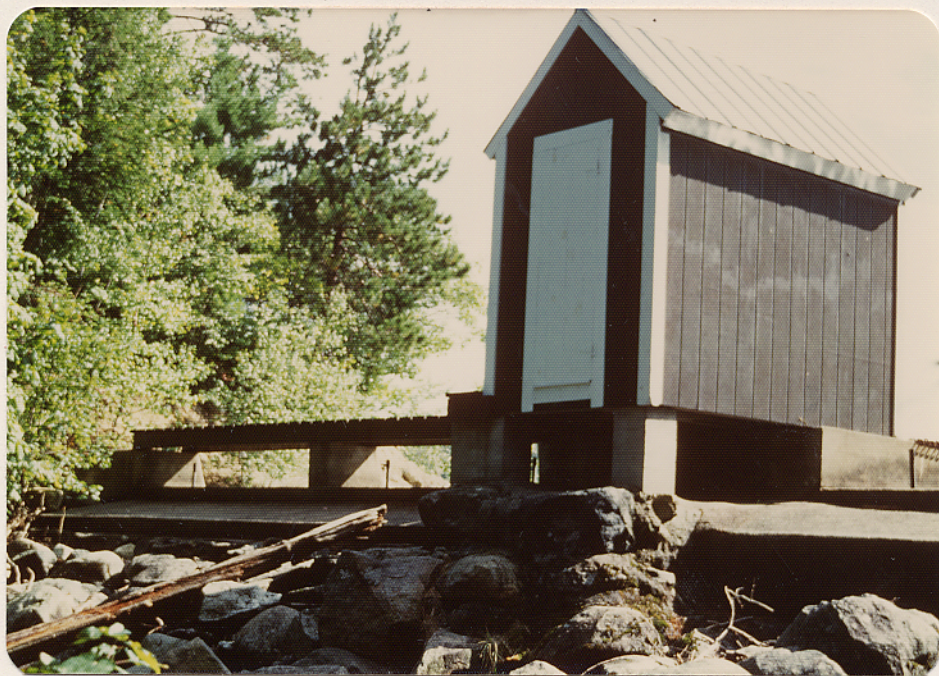
Overview of right side of dam and
gatehouse from downstream

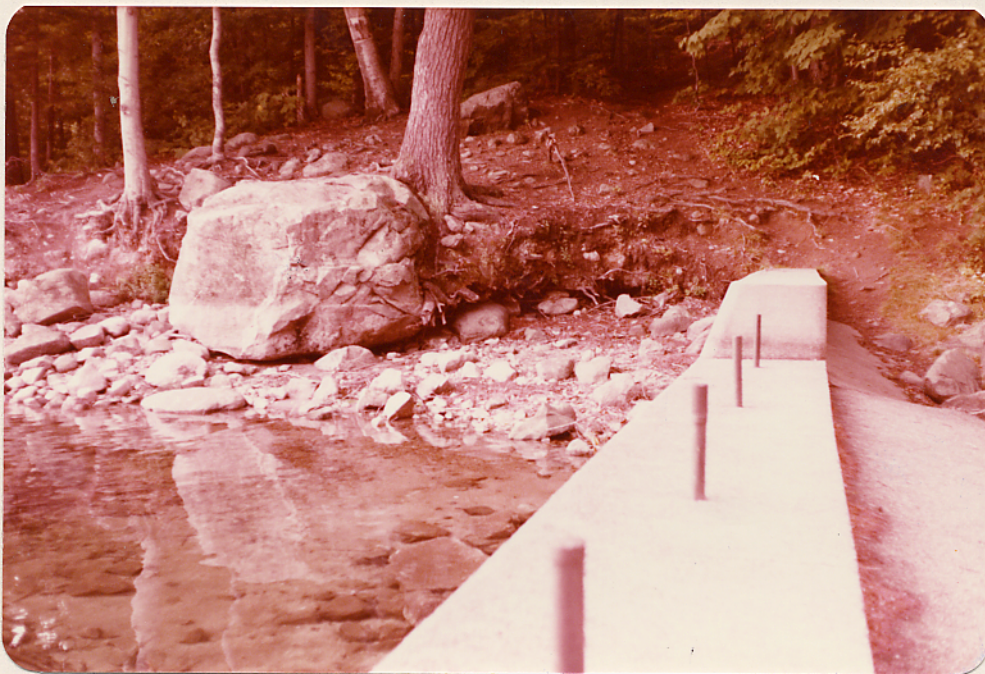
1. View of left abutment area showing erosion around end of dam

- (1) Clear all debris from the downstream channel and trim or remove all overhanging trees.
- (2) Repair the eroded areas at the abutments, particularly on the left side, and provide adequate slope protection in these locations. Additionally, remove the large tree already endangered by erosion.
- (3) Clear the outlet of the discharge culvert and insure that this area remains unobstructed in the future.

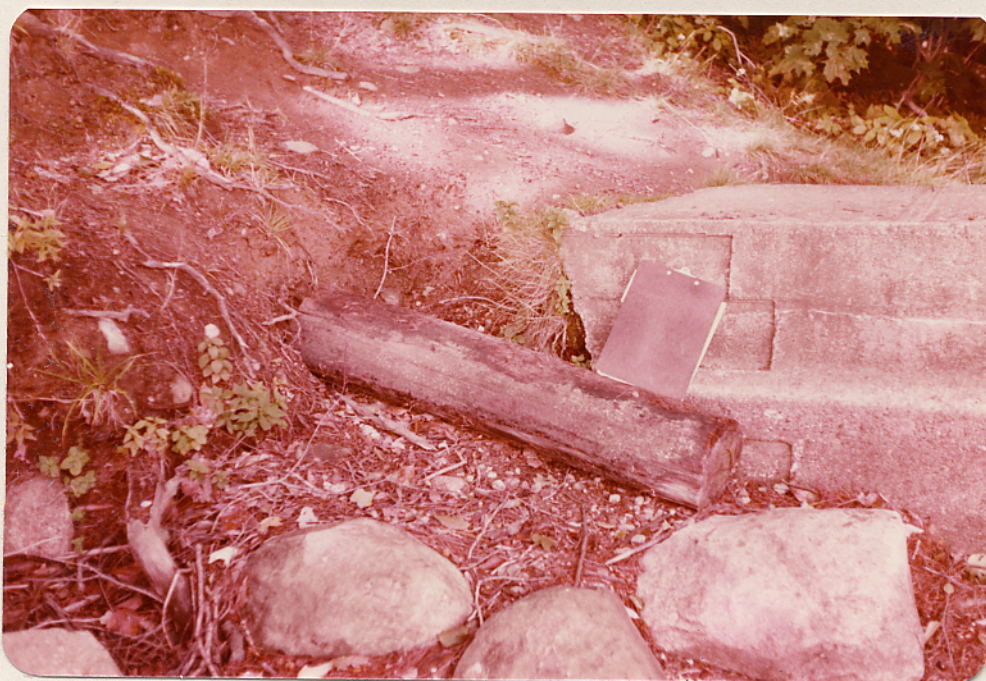
2. Detail of photo #1

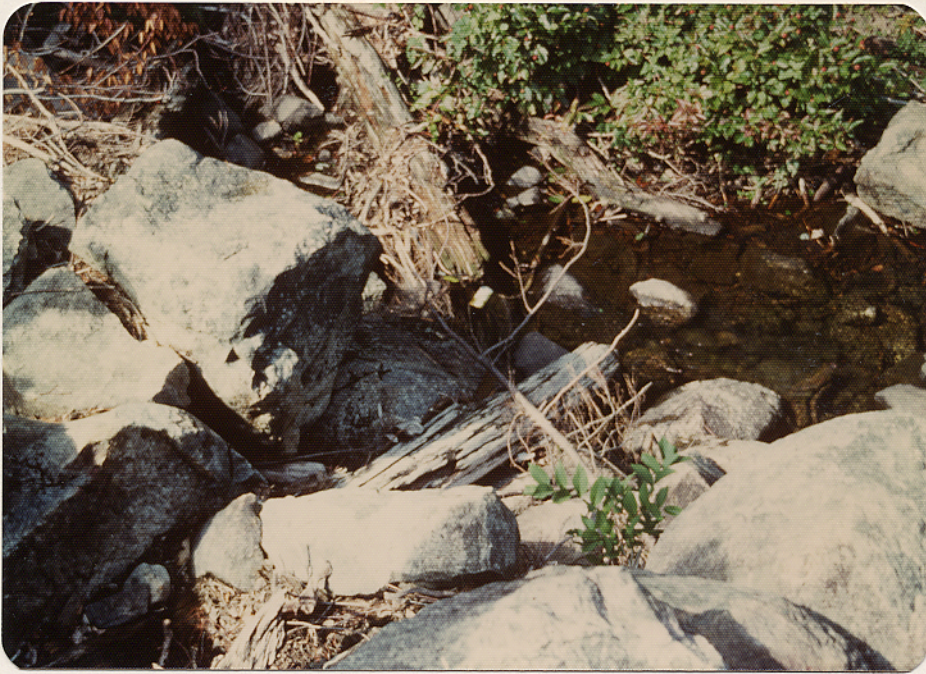
A significant amount of seepage exists at the toe of the dam approximately 10 feet left of the gate house. This same area is shown on the 1958 sketch with the notation "bad leak here" over a 15 square foot area. It is apparent that an unsuccessful attempt was made to repair the seepage as an excavation approximately 4 to 6 feet wide exists in the downstream boulder slope at this location. The fact that a seepage of this size has existed for over 20 years raises serious questions as to what extent the foundation of this dam has been damaged.

The significant seepage at the toe of the dam is a deficiency with potentially hazardous consequences. The existence of such a situation for as long as 20 years raises doubts as to the integrity of the dam's foundation. For this reason, the dam must be rated in POOR condition as long as this problem remains undefined. If corrected, the evaluation would change to fair. In general, because most of the dam's major components are accessible for inspection, the visual inspection permitted an overall satisfactory evaluation of those items which affect the safety of the structure.

3. View of seepage at downstream toe

- (a) The discharge capacity of the dam should be improved or suitable emergency spillway facilities provided.
- (b) The foundation seepage should be investigated immediately.
- (c) The height of the abutment should be increased to preclude the flow of water around the ends of the dam.
- (d) The potential hazard presented by the possible failure of the old mill dam should be mitigated by repair of the dam so that it could survive a failure of Dan Hole Pond Dam or by removal of the structure.
- (e) Periodic technical inspections should be accomplished annually.

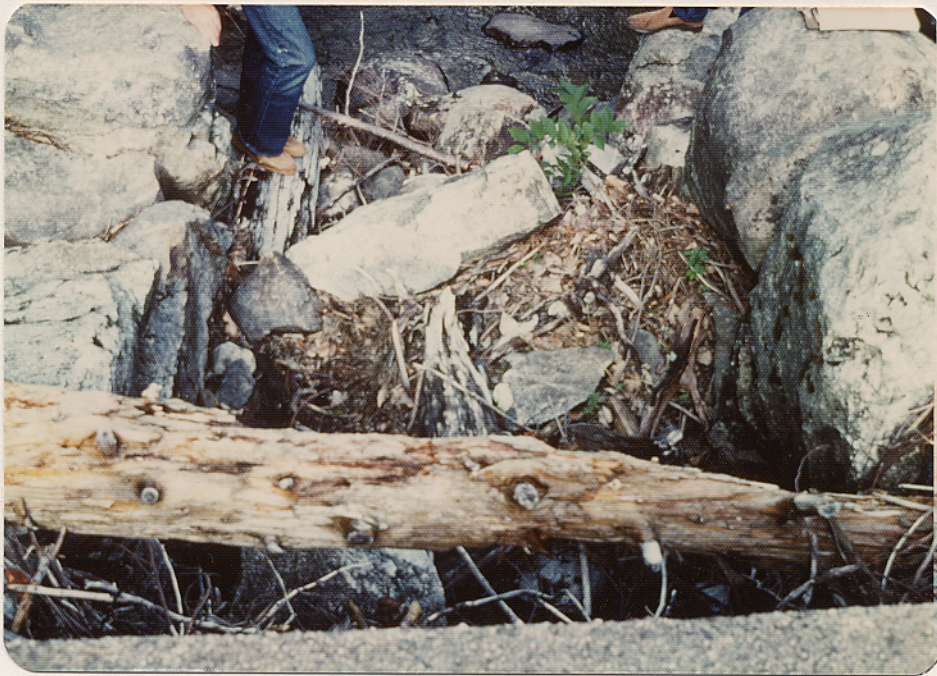
4. View of excavated area in downstream
dumped boulder slope
